[By Charles C. Hoover, Jr. P.E.](#)

In this article we will:

- A summarize observations made by the author and others who have investigated residential areas impacted by Hurricane Andrew,
- provide an elementary overview of wind effects on residential buildings with particular attention to the roof structure and gable end trusses,
- suggest steps that need to be taken to improve the performance of residential structures under high wind conditions.

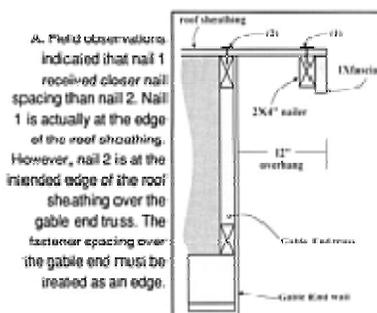
Myth 1 - A gable end truss is non-structural. This misperception may occur because the structural portions of the end wall are visible only in the early stages of construction, and then are covered. In fact, the gable end truss is an integral structural component of the gable end wall. Here's how it functions.

The gable end truss receives load from the roof sheathing, transfers "gravity" loads through the top chord to the vertical webs, through the bottom chord, and into the top of the bearing wall. Examples of these loads are the "dead" weight of the roof itself, construction materials, snow, etc. Gable end trusses also support the roof diaphragm and transfer the shear load from the diaphragm to the supporting gable end walls.
